**ANALYSIS AND INTERPRETATION OF THE INTERIOR
PAINTED FINISHES OF THE MATHEWS-LOCKWOOD MANSION**

Susanna C. Fourie

Historic Preservation

1997

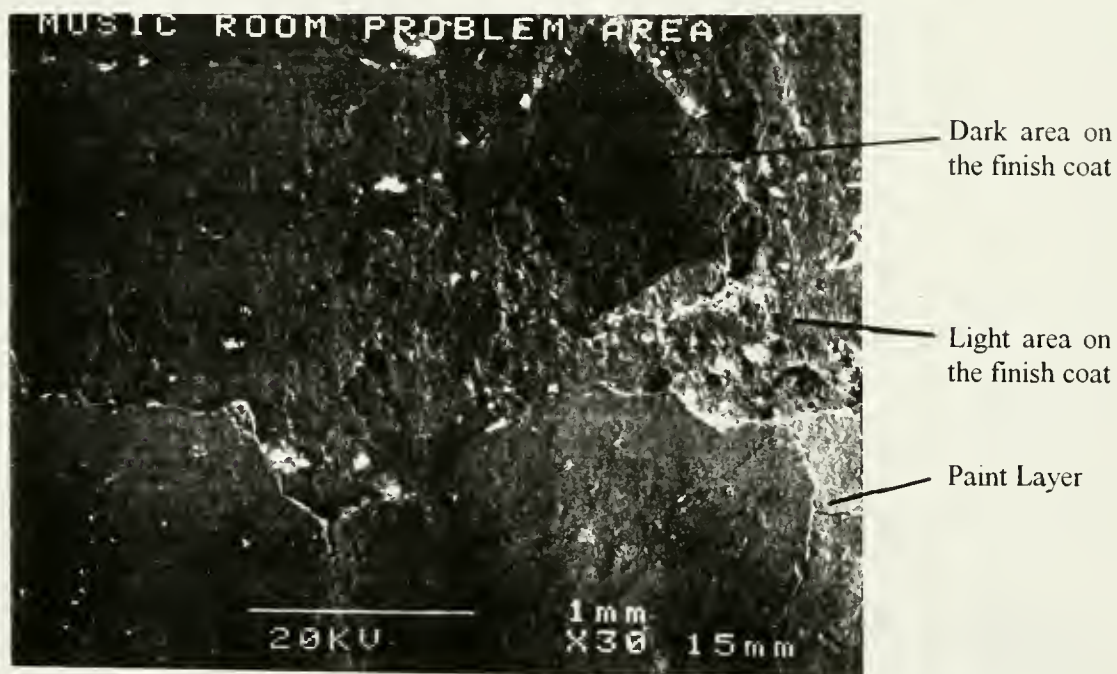
Figure 59: Secondary Electron Image of Sample 60: Music Room

This sample is carbon coated. The sample is from the field where the paint failure is present. A study was made of the moisture damaged and undamaged areas. X-Ray energy dispersive analyses were done on the dark and light areas of the secondary electron image. It indicates that gypsum recrystallises below the paint layer.

The dark area as indicated in figure 59 shows gypsum crystals are forming. Mostly sulphur is present - no lead.
